IBIS (In-Flight Blade Inspection System)

Radiation Hazard Awareness and Permit Requirements Training

NAVAIR-CNAF NAVAIR 09F/7.10.1 June 2015

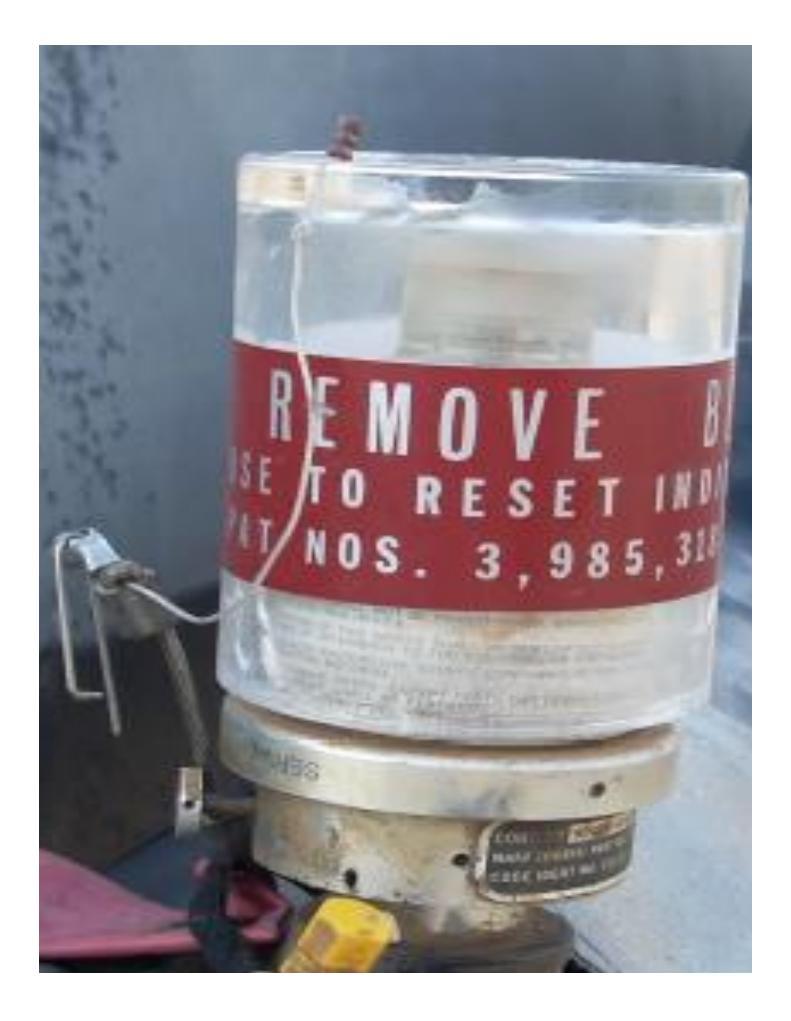
- IBIS is a device that provides inflight warning of blade failure on CH/MH-53E helicopters
- Part numbers:
 - 12210-1
 - 12220-1
- NIIN:
 - 01-125-8904: (CH/MH)
- Cover part number:
 12239-1
- Cover NIIN:
 - 01-125-0659
- Contains sealed radioactive source (Strontium-90)

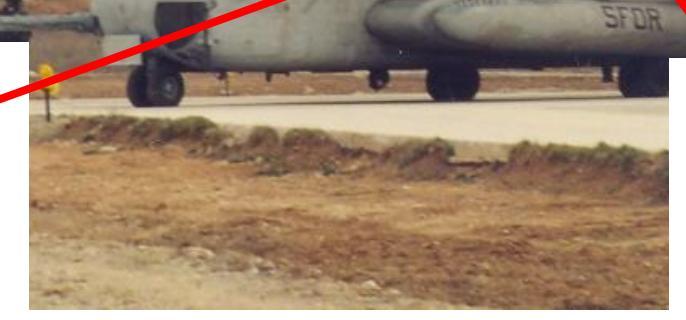
Pressure Indicator If pressure is lost in the blade a button is released . This button, when triggered, exposes a small radiation source. The signal is picked up by the detector assembly.

Signal Processor The signal processor picks up the message which illuminates the master caution lights on cockpit panel.

Detector Assembly Picks up radiation signal from the pressure indicator and sends a signal to the signal processor.

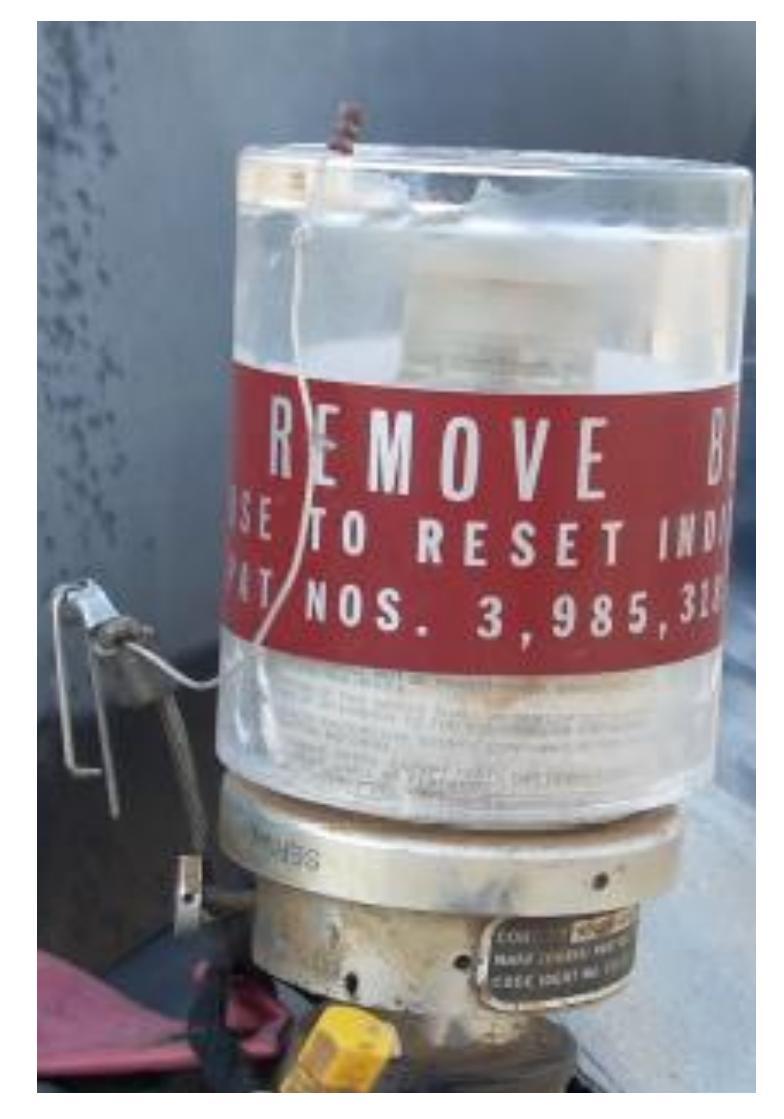
- The radiation source is in shielded (safe) condition when blade pressure is normal and IBIS is installed
- Emits radiation only when blade looses pressure, by pressing the manual test button, or removing the IBIS from the blade.
- Shown with protective cover that shields (protects) from radiation

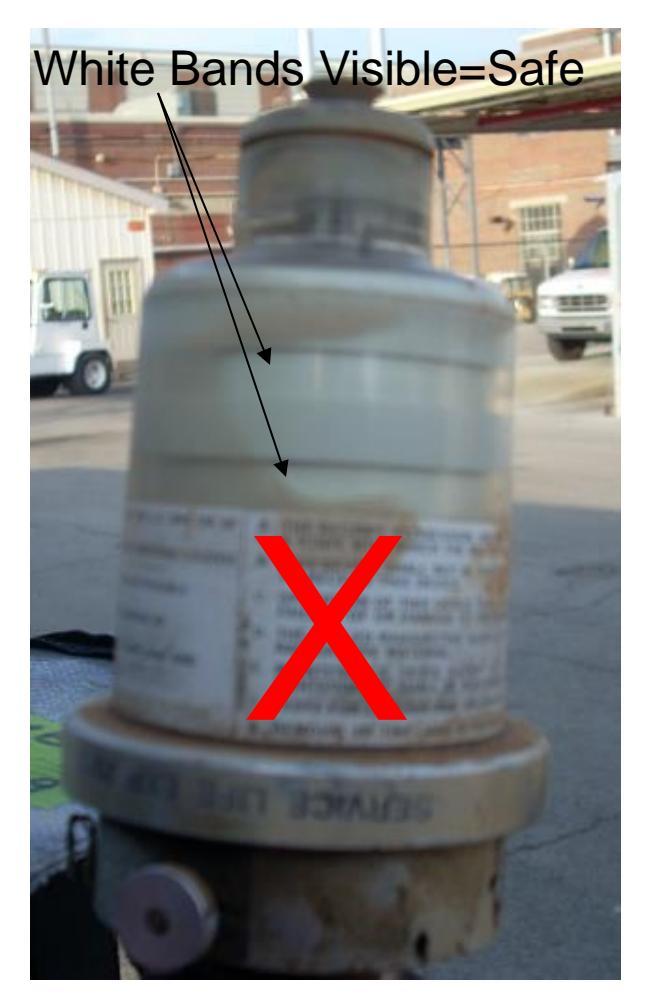
- IBIS without cover
- When indicator is normal position (blade pressurized) white bands are visible.
- Strontium 90 source is inside a shield that absorbs nearly all radiation

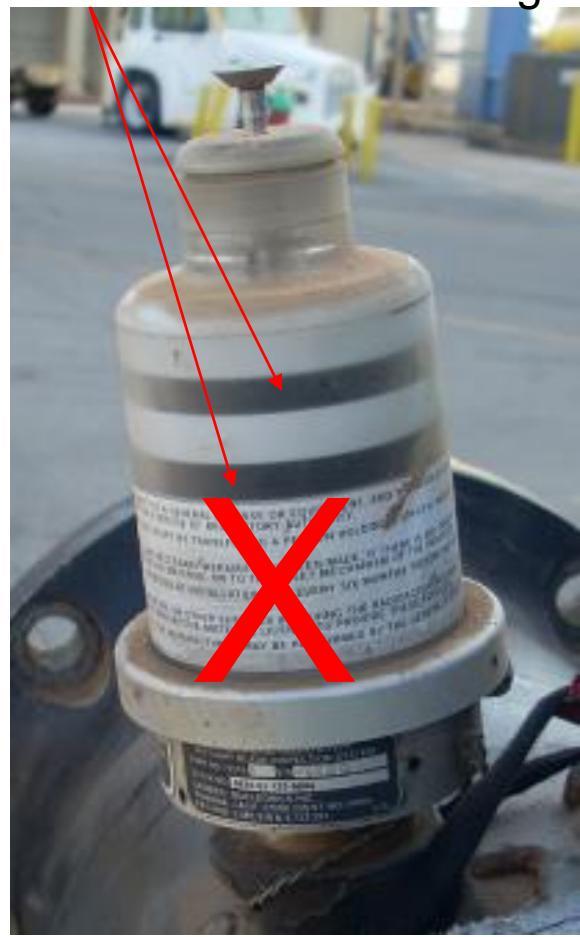
- IBIS device showing black (depressurization)
- Exposure hazard exists when the blade has lost pressure, the self test button is activated, or the IBIS is removed from the blade.
- The Strontium 90 source is out of its shield and beta radiation is emitted in a 360° "doughnut" pattern around the end of the indicator.
- Reset button on top (should only be used in conjunction with protective cover)
- A shipping cover is provided with each indicator, which absorbs nearly all the radiation from the source

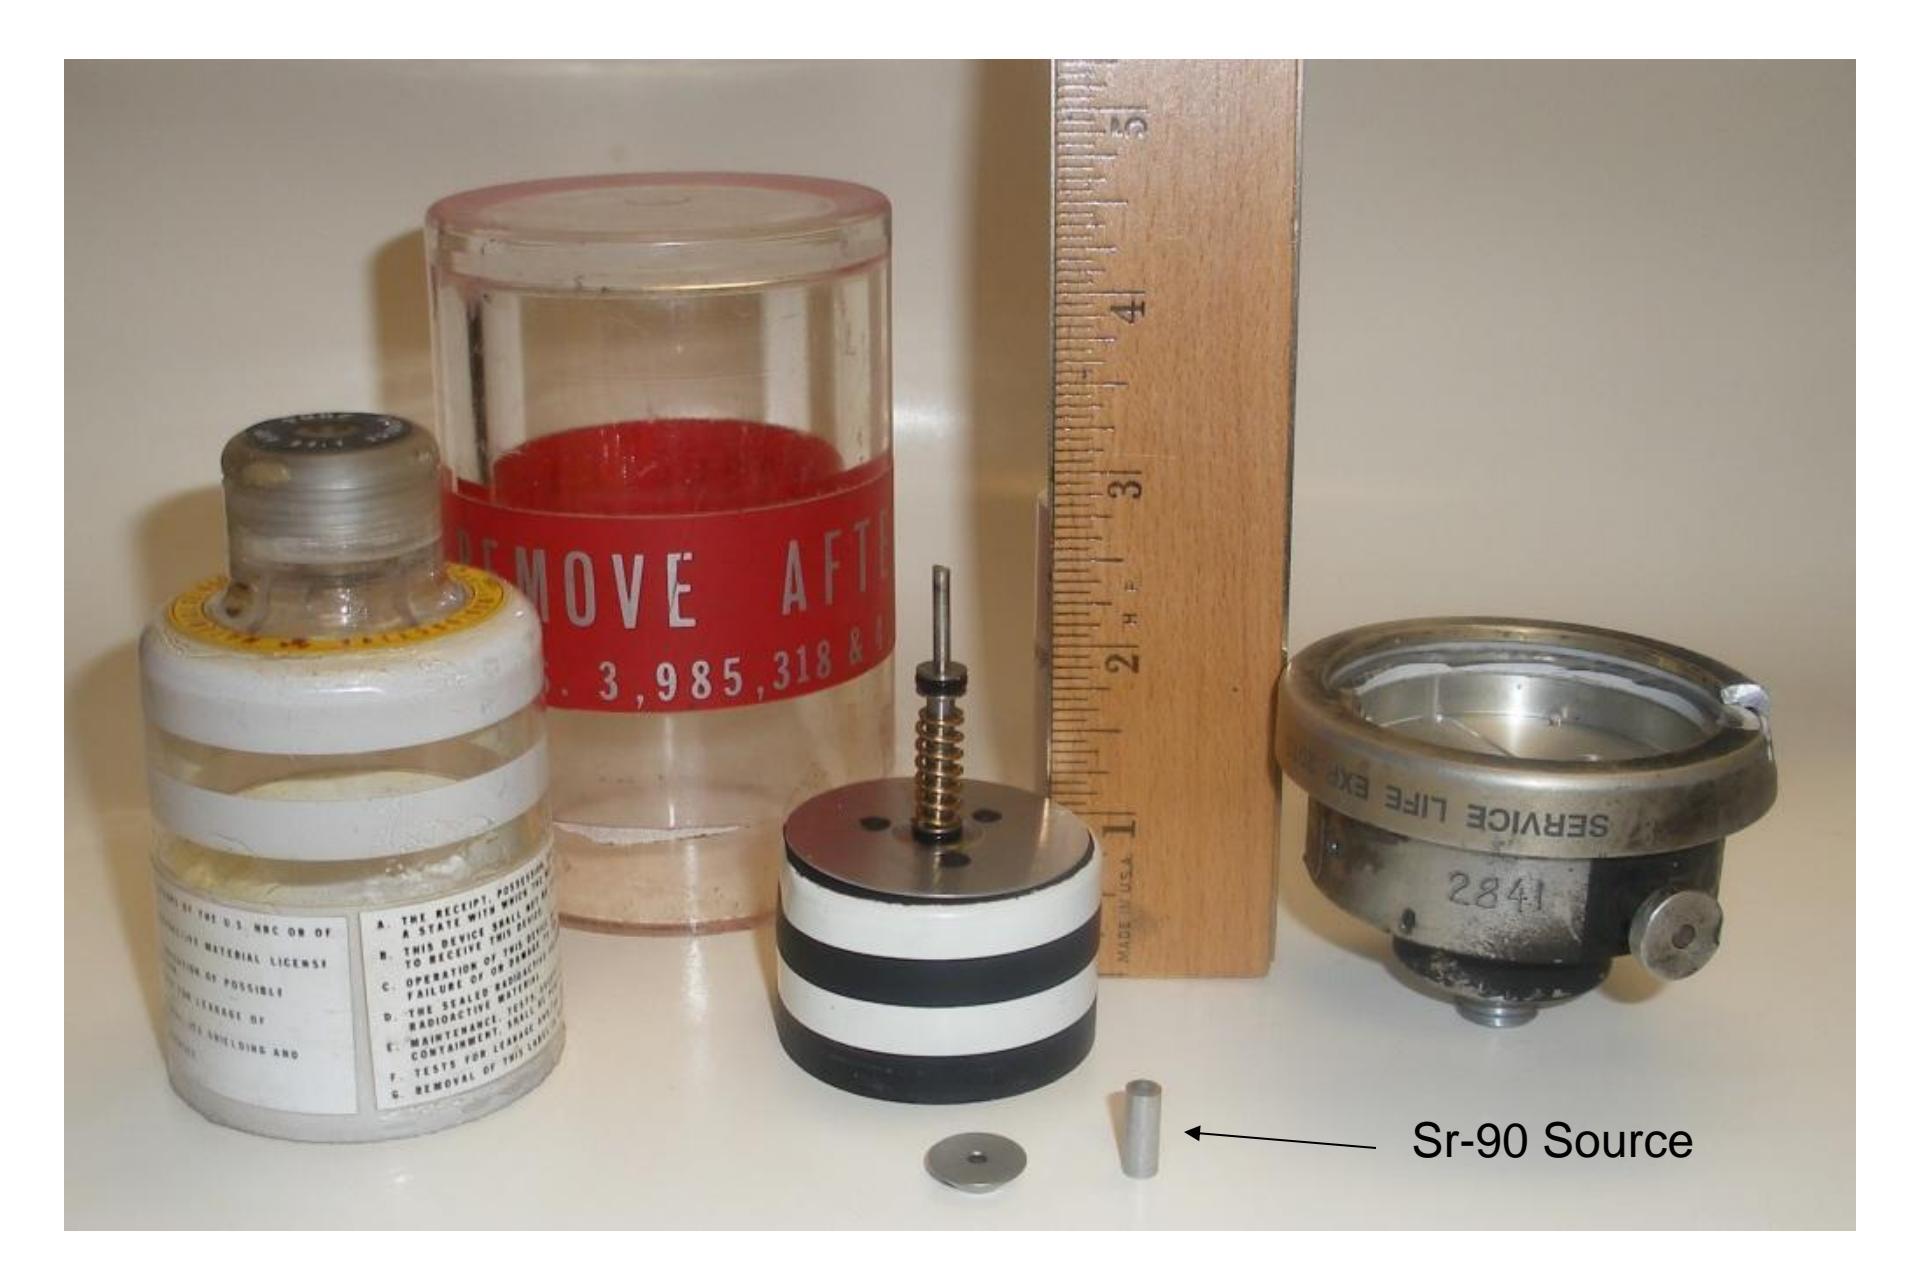
- If IBIS device is damaged or falls off the aircraft:
 - Attempt to locate the device
 - If the IBIS is located, shield the IBIS with a protective cover and determine if the radioactive source is still on the device
 - Use following pictures as references

IBIS Strontium 90 Source (500uCi) ~0.476 inches THE REAL PROPERTY AND ADDRESS OF THE PROPERTY AND ADDRESS OF THE PROPERTY AND ADDRESS OF THE PROPERTY AND IN THE PARTY OF THE TRANSPORT OF TRANSPORT Radioactive Source
